**Flood Control Project Maintenance
Levee Inspections**

Fall 2012 Levee Maintenance Deficiency Summary Report

San Joaquin River Basin

Madera County FCWCA

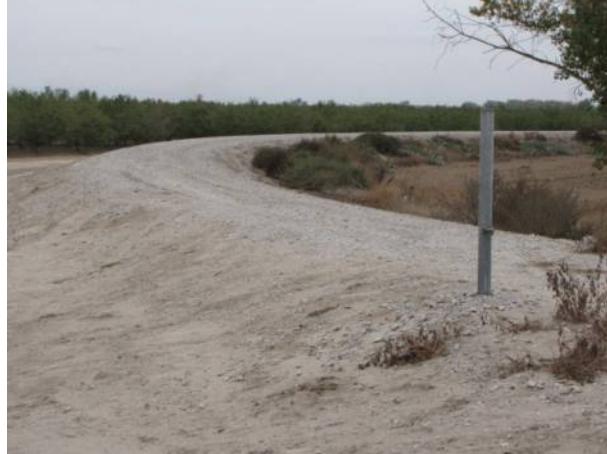
Ash Slough levee mile 0.91-2.41 land side void of vegetation downstream. Photo taken 11-01-2012.

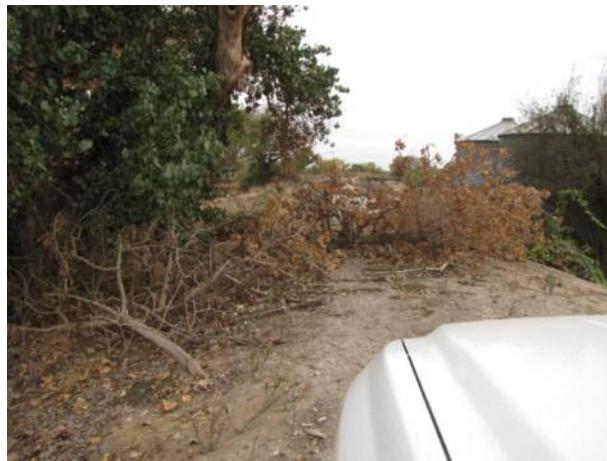
Ash Slough Unit 1 levee mile 0.96 tree fell across levee section. Photo taken 11-01-2012.

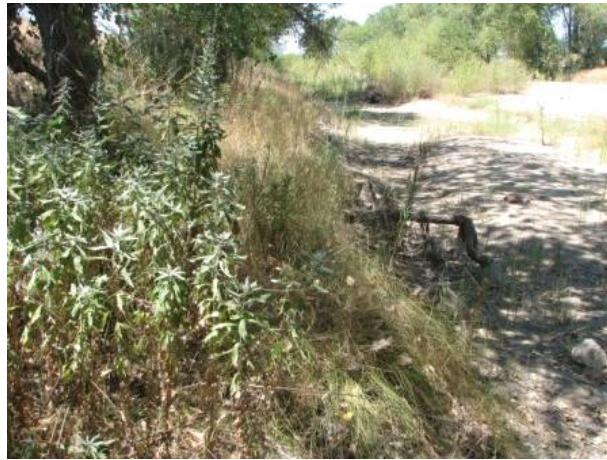
| Waterway | | | | | | | | Bank | Unit Miles | Inspection Start/End | Inspector | | |
|---|---|---|---|---|---|---|---|---|---|---|---|---|--|
| 18 | 1.11 | 1.20 | Supplemental Erosion Survey | | WS | M | Inspector Comments: 07/31/2012: Site was visited on 07/24/2012. No significant change observed. Dense vegetation around the site 08/09/2011: Site was inspected. No visible change was observed from the previous condition. A fallen tree was seen at the levee toe about 20 feet upstream, and tree root exposed. There has been no report from the district that this site was corrected. 11/30/2010: Site was not inspected due to time constraints. There have been no reports from the district that the site was corrected. Continue to monitor site during flood events. 08/05/2010: Recommended for annual assessment and monitoring during flood events, per CLRO. 2009: Site is recommended as a local maintenance issue, per Critical Levee Repair Office, Critical Erosion Sites Evaluation 2008 Report; site was previously rated "M" 9/6/2007: Undercutting of the toe; several trees along the WS slope with roots exposed. [2012 Site ID:NA0011U01RM2.57] | | | 37.055596 ° | 37.055596 ° | 1 | |

Close-in view at the erosion site

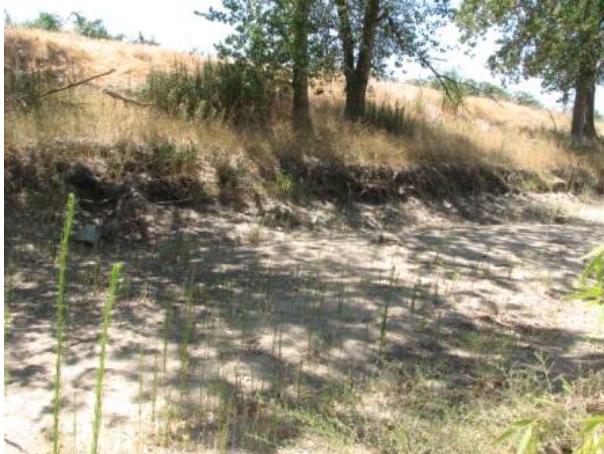
View from the riverbed

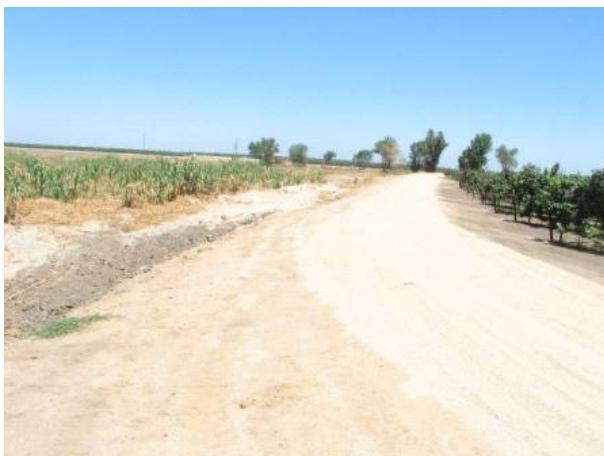
| LMR No. | Levee Mile | | Category | Item | * Location | ** Rating | Action/Comment | GPS Latitude/Longitude | | Issue No. | | | |
|---|---|---|---|---|---|---|---|---|---|---|---|---|---|
| 20 | 2.37 | 2.39 | Supplemental DWR Erosion Survey | WS M | Ma | Inspector Comments: 07/31/2012: Site was visited on 07/26/2012. No significant changes observed 08/09/2011: Site was inspected. No visible change was observed from the previous condition. There have been no reports from the district that this site was corrected. 11/30/2010: Site was not inspected this year due to time constraints. There have been no reports from the district that this site was corrected. Continue monitor during flood events. 08/05/2010: Recommended for annual assessment and monitoring during flood events, per CLRO. 2009: Site is recommended as a local maintenance issue, per CLRO CES Evaluation 2008 Report; it was previously rated "M". 8/26/2008: Undulating waterside slope surface; vehicular damage along the waterside slope possibly caused by farming equipment; levee crown is composed of sandy material; there is a collection of concrete rubble on the waterside crown hinge; vehicular damage extends from levee toe to crown surface. 9/6/2007: Farmer degraded levee on waterward slope and crown. [2012 Site ID:NA0011U01RM3.8] | | 37.068570 ° | 37.068570 ° | 2 | -120.398620 ° | -120.398620 ° | Y |

Close look at the site

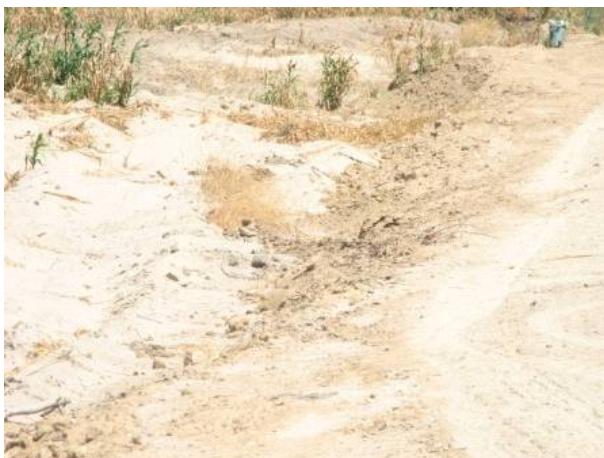
New dirt added to the levee

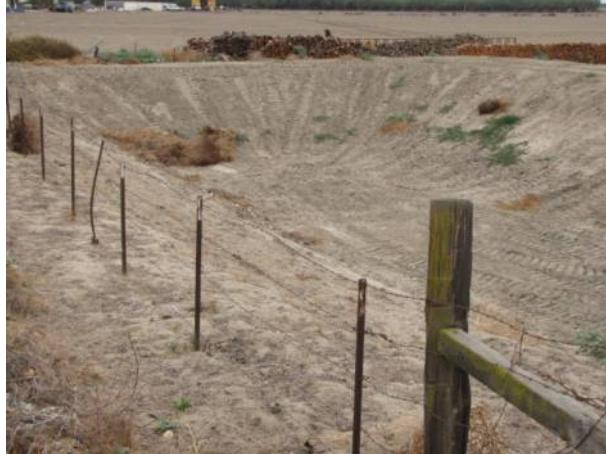
| Ash Slough Levee mile 0.01-0.03 pond dug landward. Photo taken 11-01-2012. | phillips_f_20121120_400.jpg |

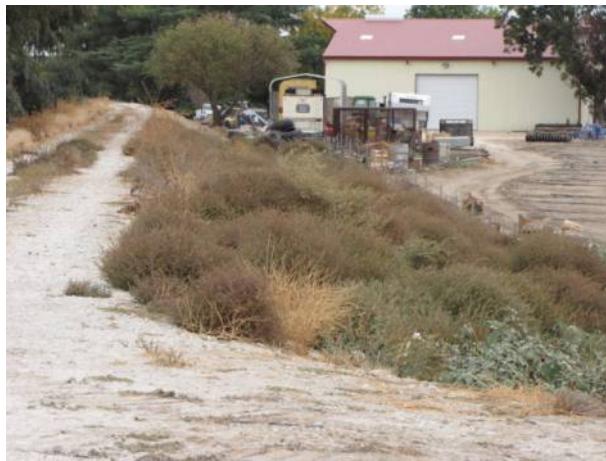
| Ash Slough wild growth on landside slope. Photo taken 11-01-2012. | phillips_f_20121120_401.jpg |

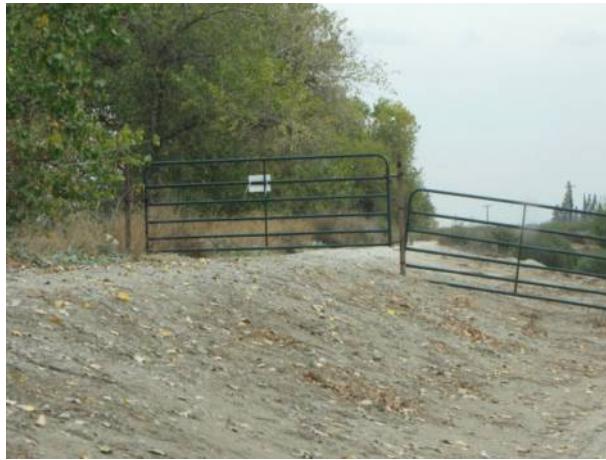
| Unauthorized fence placed across levee crown with lock (no access). Photo taken 11-01-2012. | phillips_f_20121120_403.jpg |

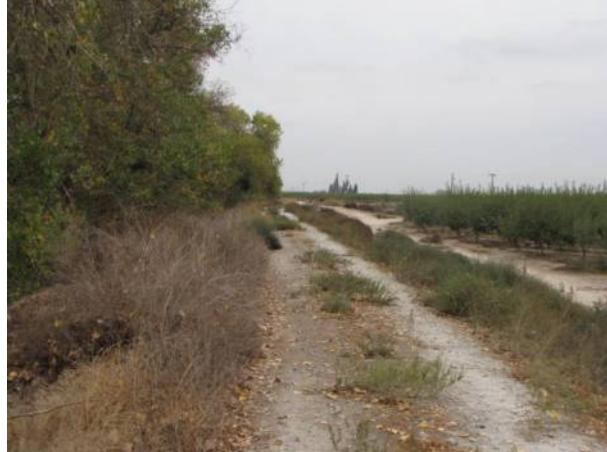
| Ash Slough wild growth on waterside both slopes and crown. Photo taken 11-01-2012. | |

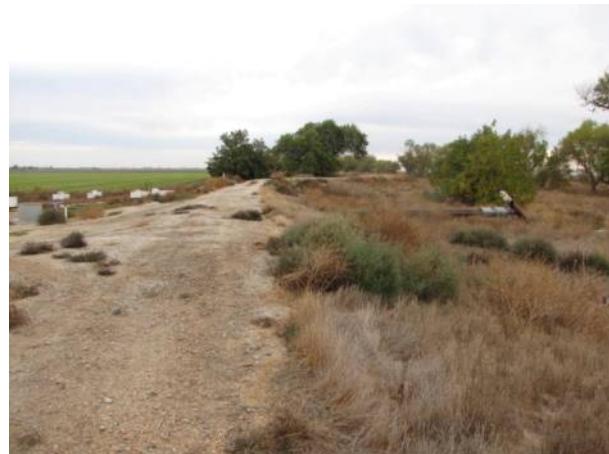
| Berenda Slough Unit 3 levee mile 0.00, levee is not being maintained. Photo taken 11-01-2012. | phillips_f_20121204_432.jpg |

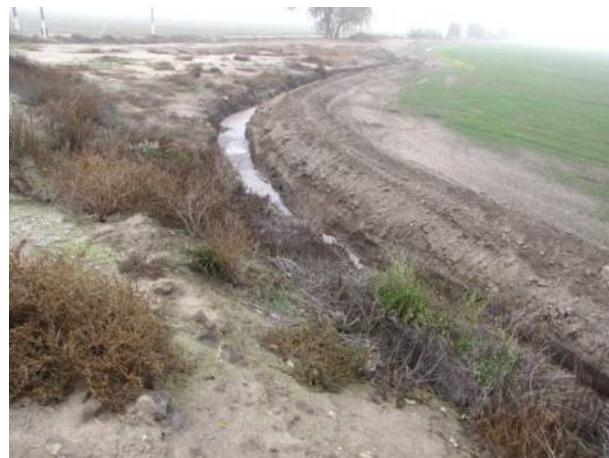
| Unauthorized agriculture ditch landward toe. Photo taken 11-23-2011. | phillips_f_20120911_014.jpg |

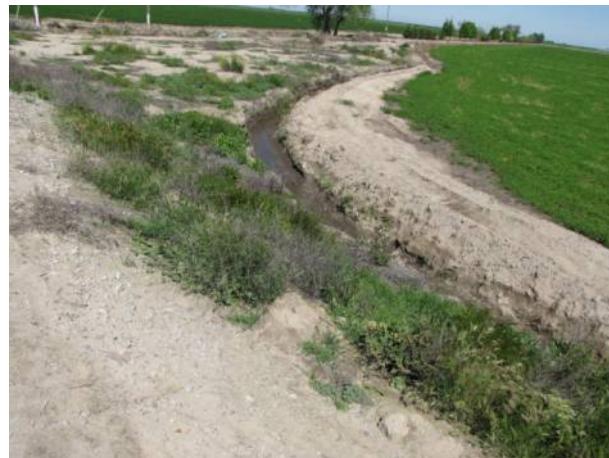
| Agriculture ditch continues along land side within the 10-foot of levee toe. Photo taken 4-18-2012. | phillips_f_20120911_015.jpg |

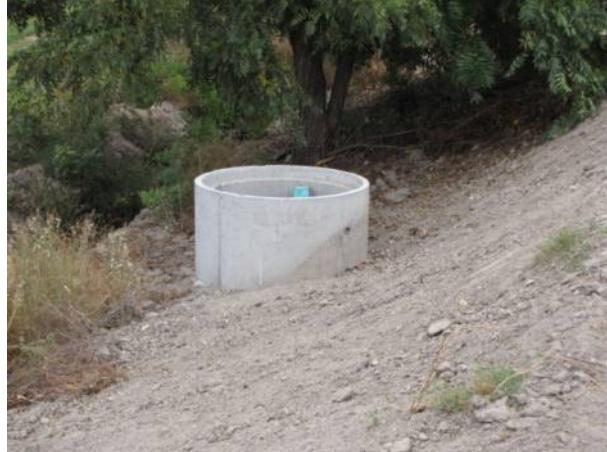
| This encroachment has been listed, we are waiting for the CVFPB Permit from Chowchilla Flood Control. Photo taken 11-01-2012. | |

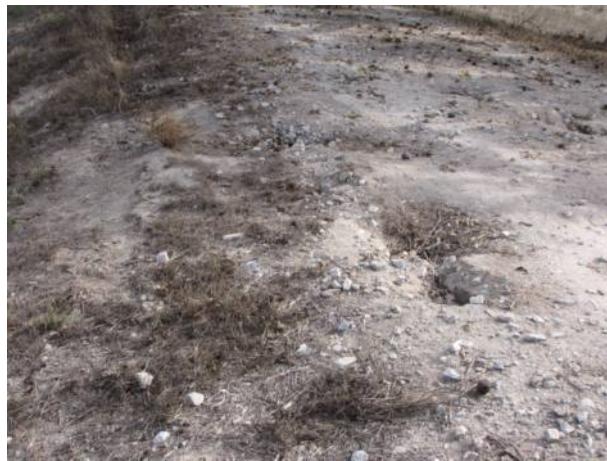
| There are several rodent holes in the shoulder and crown of the roadway. | |

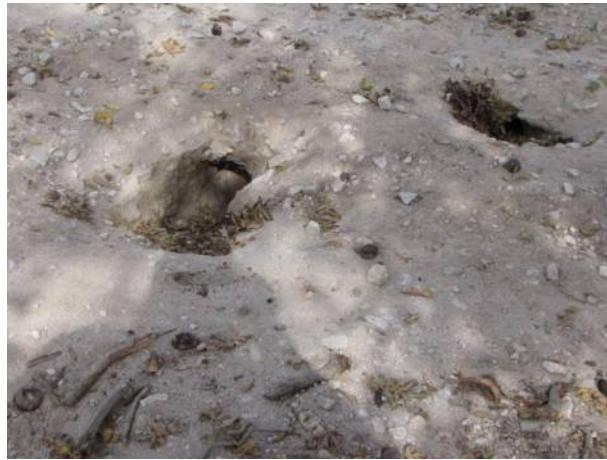
| This photo shows holes in crown and shoulder. | |

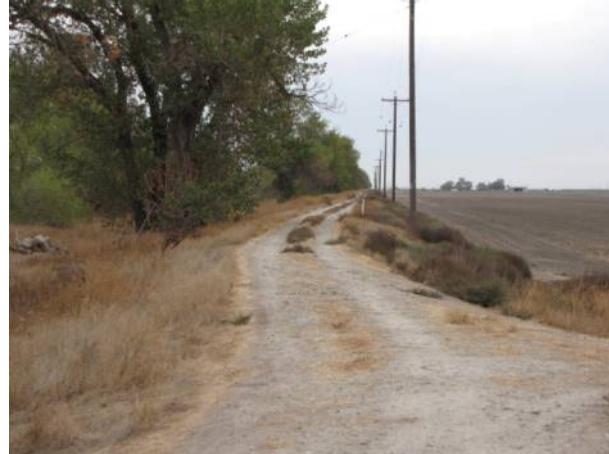
| Berenda Slough Unit 4 levee mile 0.01 looking back upstream. Photo taken 11-01-2012. | |

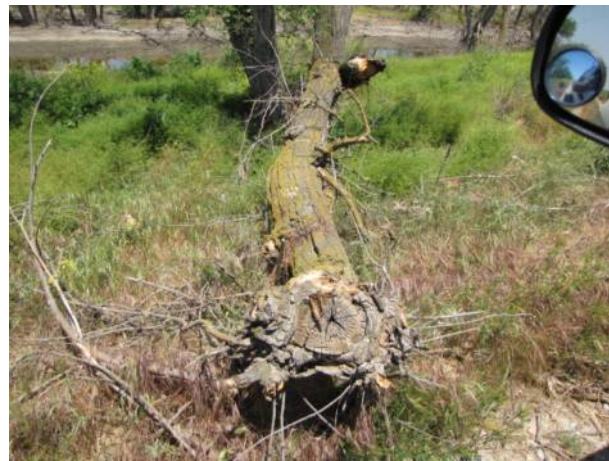
| This tree needs to be cut up and removed from levee section. | |

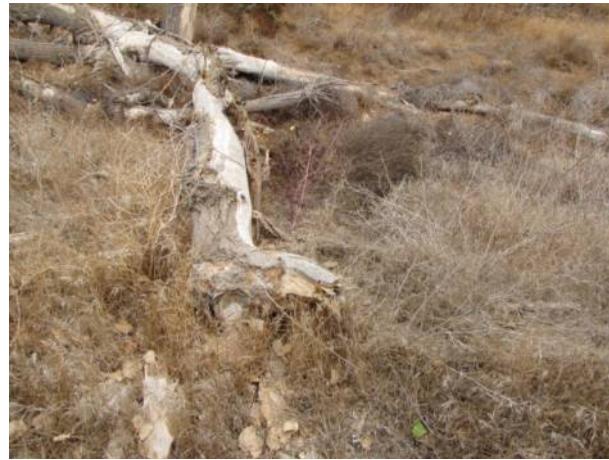
| This tree has not been cut up since last two inspections. Phot taken 11-01-2012. | |

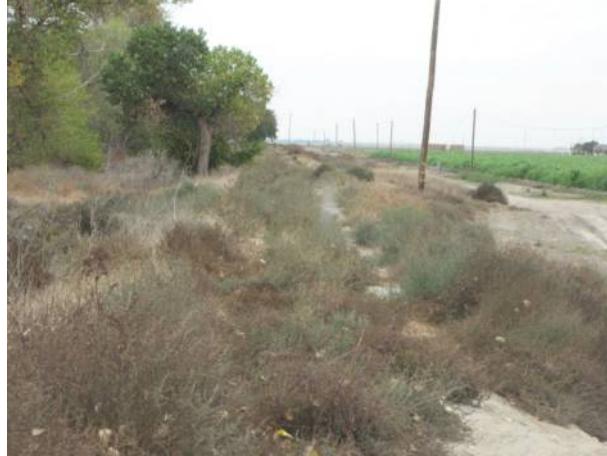
| This levee section is severely overgrown weeds exceed the unsatisfactory limits. No maintenance has been done. Photo taken 11-01-2012. | |

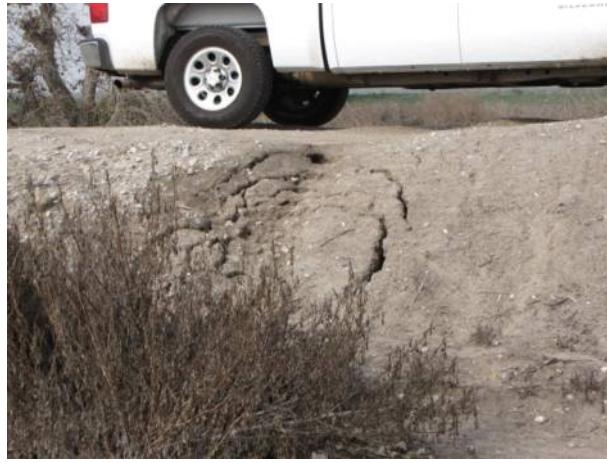
| Waterway | | | | | | | | Bank | Unit Miles | Inspection Start/End | Inspector |
|---|---|---|---|---|---|---|--|---|---|---|---|
| 18 | 1.51 | 1.51 | Earthen Levee | Slope Stability | LS Ma | U | S1 : Repair slope instability. Inspector Comments: The Madera County Resource Management Agency will be sending the landowner a letter addressing this damage. The damage here was caused by a Contractor. 11-01-2012 no repairs have been done to this site. | | | 36.995611 ° -120.346236 ° | 36.995611 ° -120.346236 ° 9 Y |

| Looking down at the erosion landward Unit 4. Photo taken 11-23-2011. | |

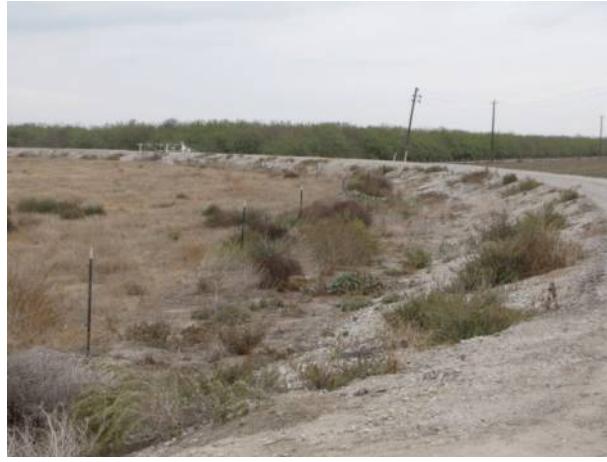
| Fence within the 10-foot of levee toe. This encroachment was recorded on the last two inspections. Photo taken 11-01-2012. | |

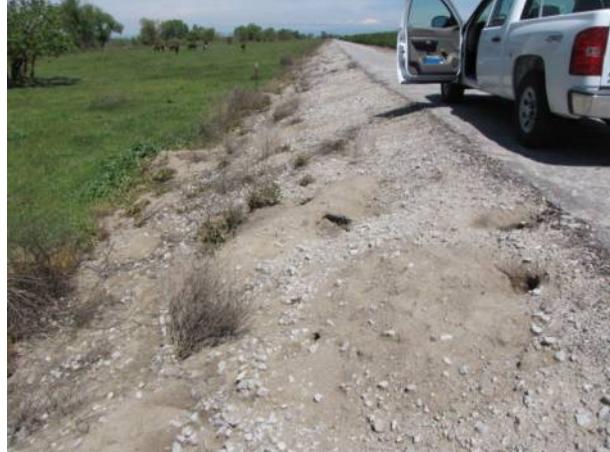
| Rodent holes all along the waterside slope and toe no bait stations in place. Photo taken 4-18-2012. | |

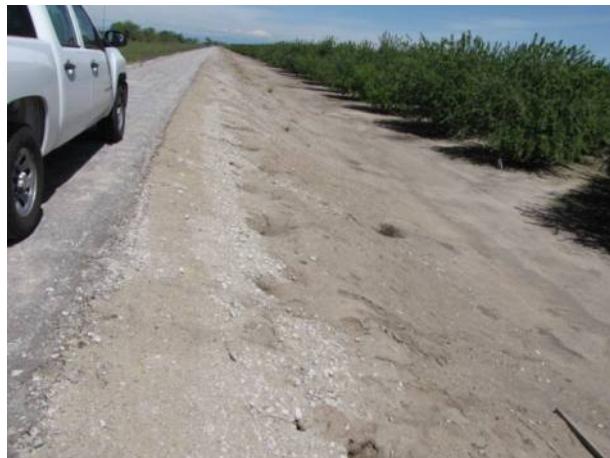
| Rodent holes all along the landward slope, no bait stations in place. Photo taken 4-18-2012. | |

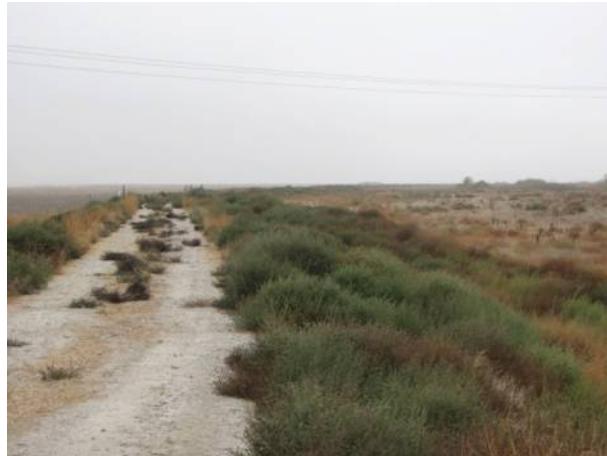
| Fresno River Unit 5 levee mile 0.00 looking downstream. Photo taken 10-31-2012. | |

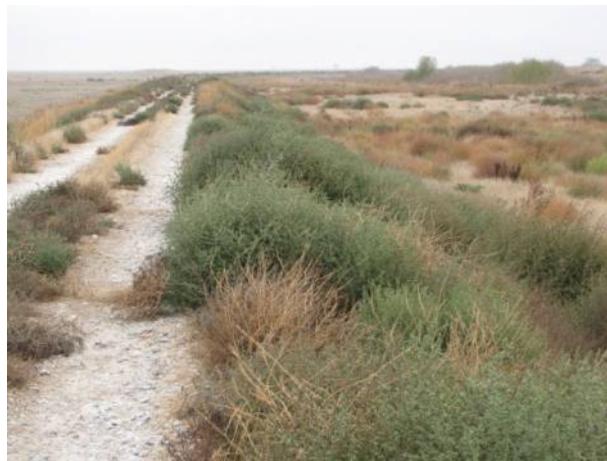
| Unit 5 Fresno River unsatisfactory growth on both levee slopes. Photo taken 10-31-2012. | |

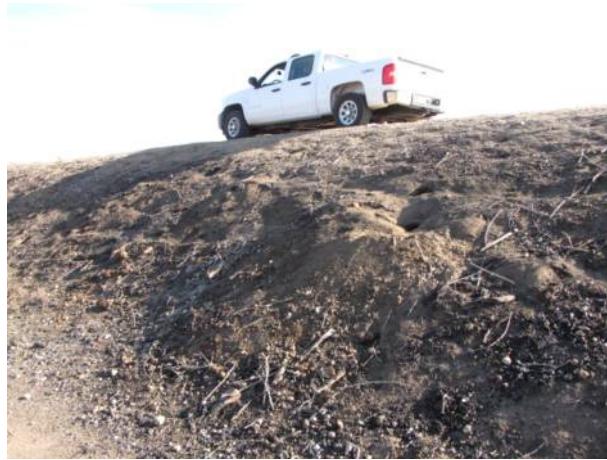
| Unsatisfactory animal control on Unit 5. Photo taken 11-22-2011. | |

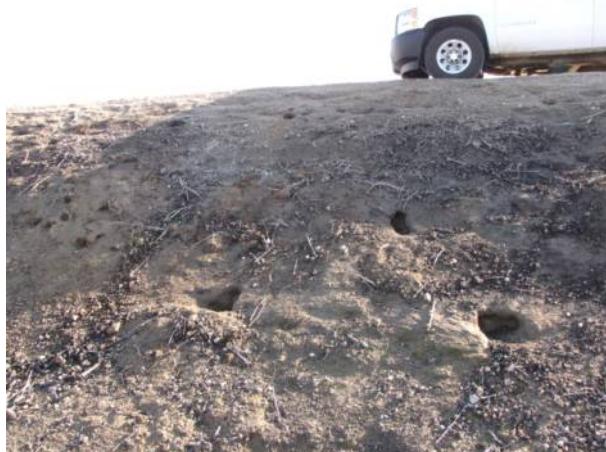
| Continuation of animal control, landward 6.67 to 6.75. Photo taken 11-22-2011. | |

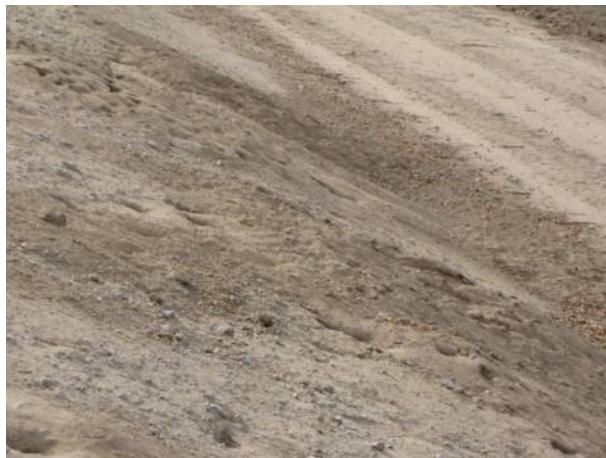
| Rodents active at this area. District needs a more aggressive approach of managing them. Photo taken 10-31-2012. This section continues from the last 2-3 reports. It is now worse than the last inspection. | |

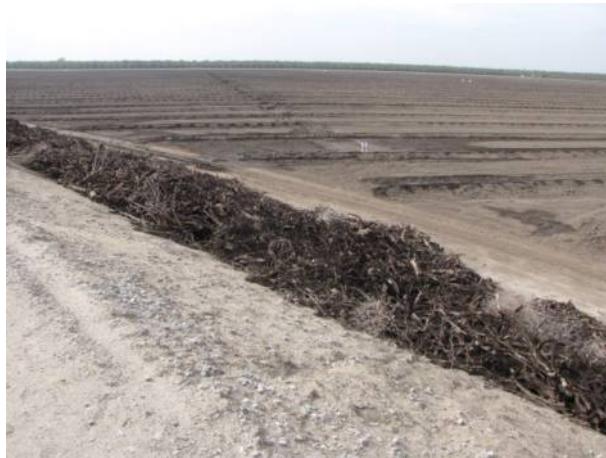
| Unsatisfactory pruning piles on levee toe. Photo taken 10-31-2012. | |

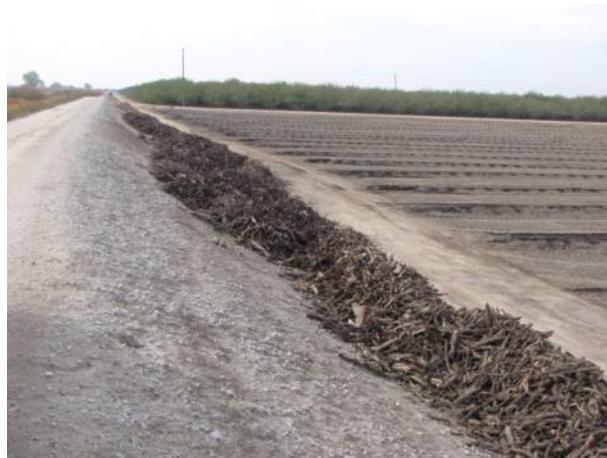
| This is unacceptable placing trimming on the toe of the levee section. Photo taken 10-31-2012. | |

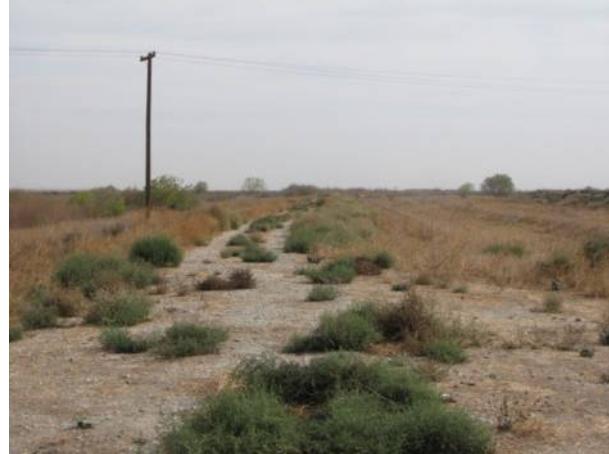
| Fresno River Levee Mile 0.00 looking back upstream. Photo taken 10-31-2012. | |

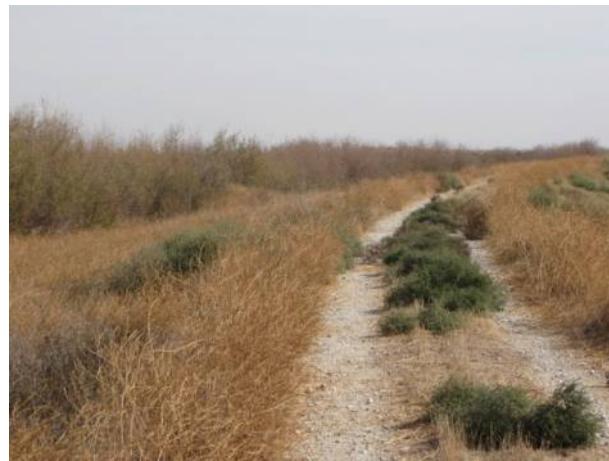
| Fresno River, unsatisfactory growth overtaken levee. Photo taken 10-31-2012. | |

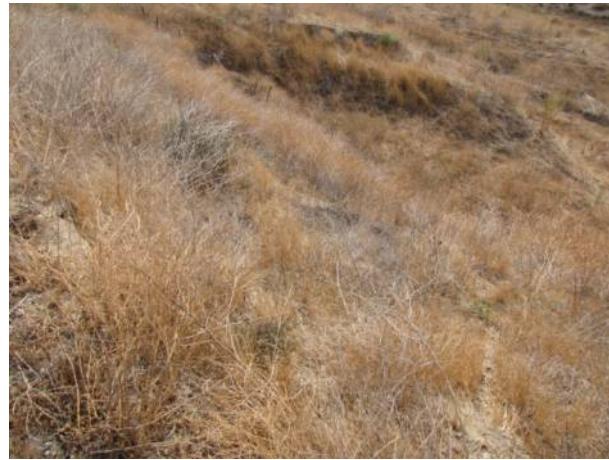
| Waterway | | | | | | | | Bank | Unit Miles | Inspection Start/End | Inspector |
|---|---|---|---|---|---|---|--|---|---|---|---|
| 9 | 0.44 | 0.44 | Earthen Levee | Erosion / Bank Caving | LS Ob | U | E2 : Schedule repair of erosion site prior to the next inspection. Inspector Comments: This erosion should be taken care of before it gets worse. | 36.975030 ° | 36.975014 ° | 20 | -120.360382 ° -120.360401 ° |

| Erosion levee toe. Photo taken 10-31-2012. | |

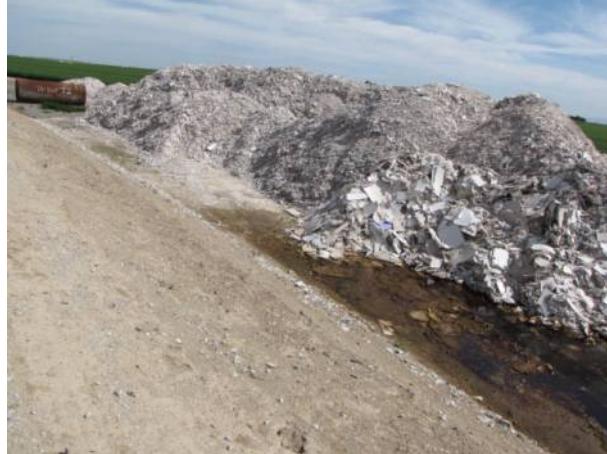
| Waterway | | | | | | | | Bank | Unit Miles | Inspection Start/End | Inspector |
|---|---|---|---|---|---|---|--|---|---|---|---|
| 11 | 1.08 | 1.12 | Earthen Levee | Encroachments | LS En | M | DE : Debris Inspector Comments: Large piles of broken up recycled sheet rock placed within 10-foot of the levee toe landward. | 36.967781 ° | 36.967407 ° | 1 | -120.353321 ° -120.352670 ° |

| Levee mile 1.08-1.12 busted up recycled sheet rock placed within the 10-foot easement landward. Photo taken 4-17-2012. | |

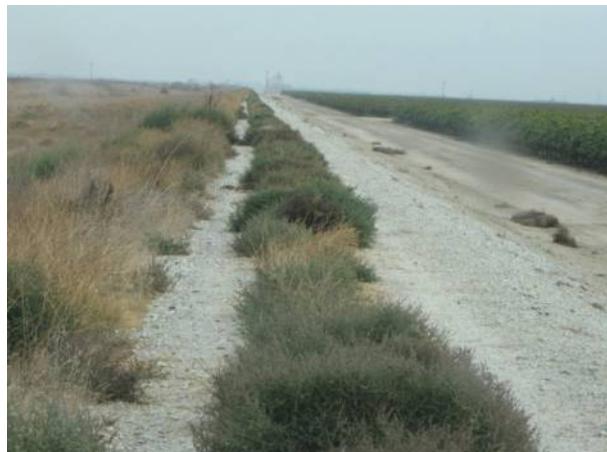
| Unsatisfactory wild growth on levee crown roadway. Photo taken 10-31-2012. | |
